XAPPER Progress on the First Wall Battle Plan

July 11, 2003

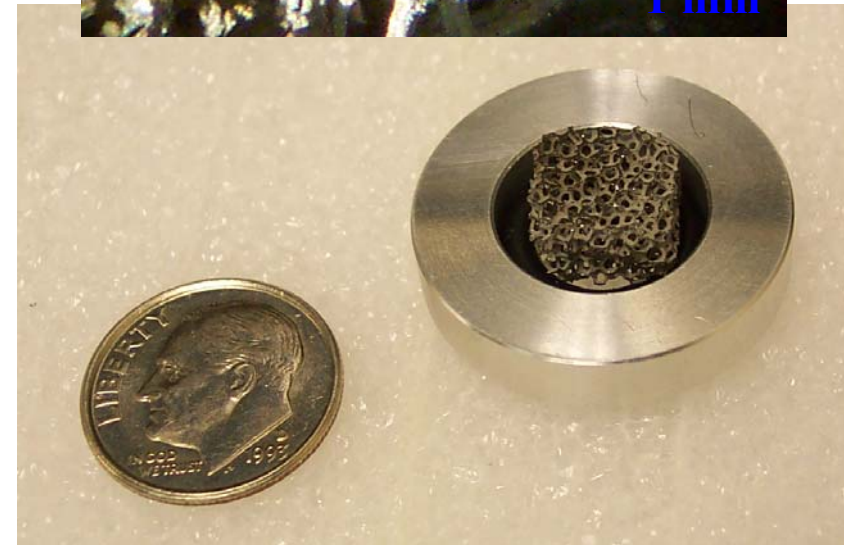
- ☐ Tungsten foam samples provided by Ultramet thanks to Shahram Sharafat:
 - 11% dense
 - 45 pores per inch
 - Nominally $1 \times 1 \times 0.5$ cm
- ☐ Baked out according to Snead guidance
- ☐ Samples hit with maximum fluence (see previous page) for 20,000 pulses at 10 Hz; started at room temperature
- ☐ Unable to perform any type of surface analysis; only optical microscopy
- ☐ No noticeable change to the material
- ☐ Same result for Re (10,000 pulses)
- ☐ Ideas for other analyses?

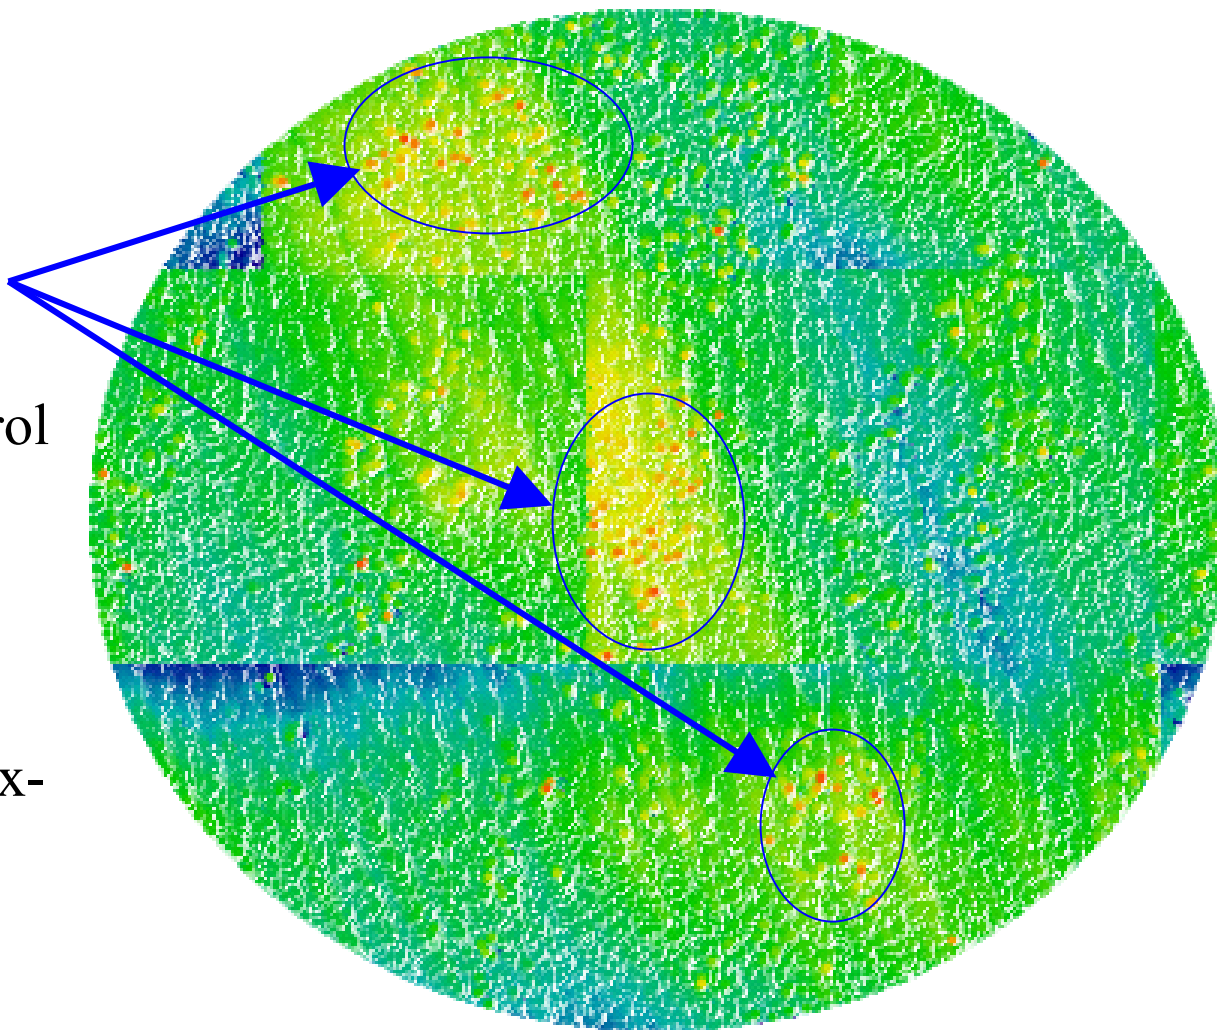
79,500 pulses

Spikes (10-20 μm
diameter,
0.3-0.4 μm high)

Don't appear on control
or 10K samples
