Power Core Safety Analysis Results

INL Fusion Safety Program

May 21, 2013

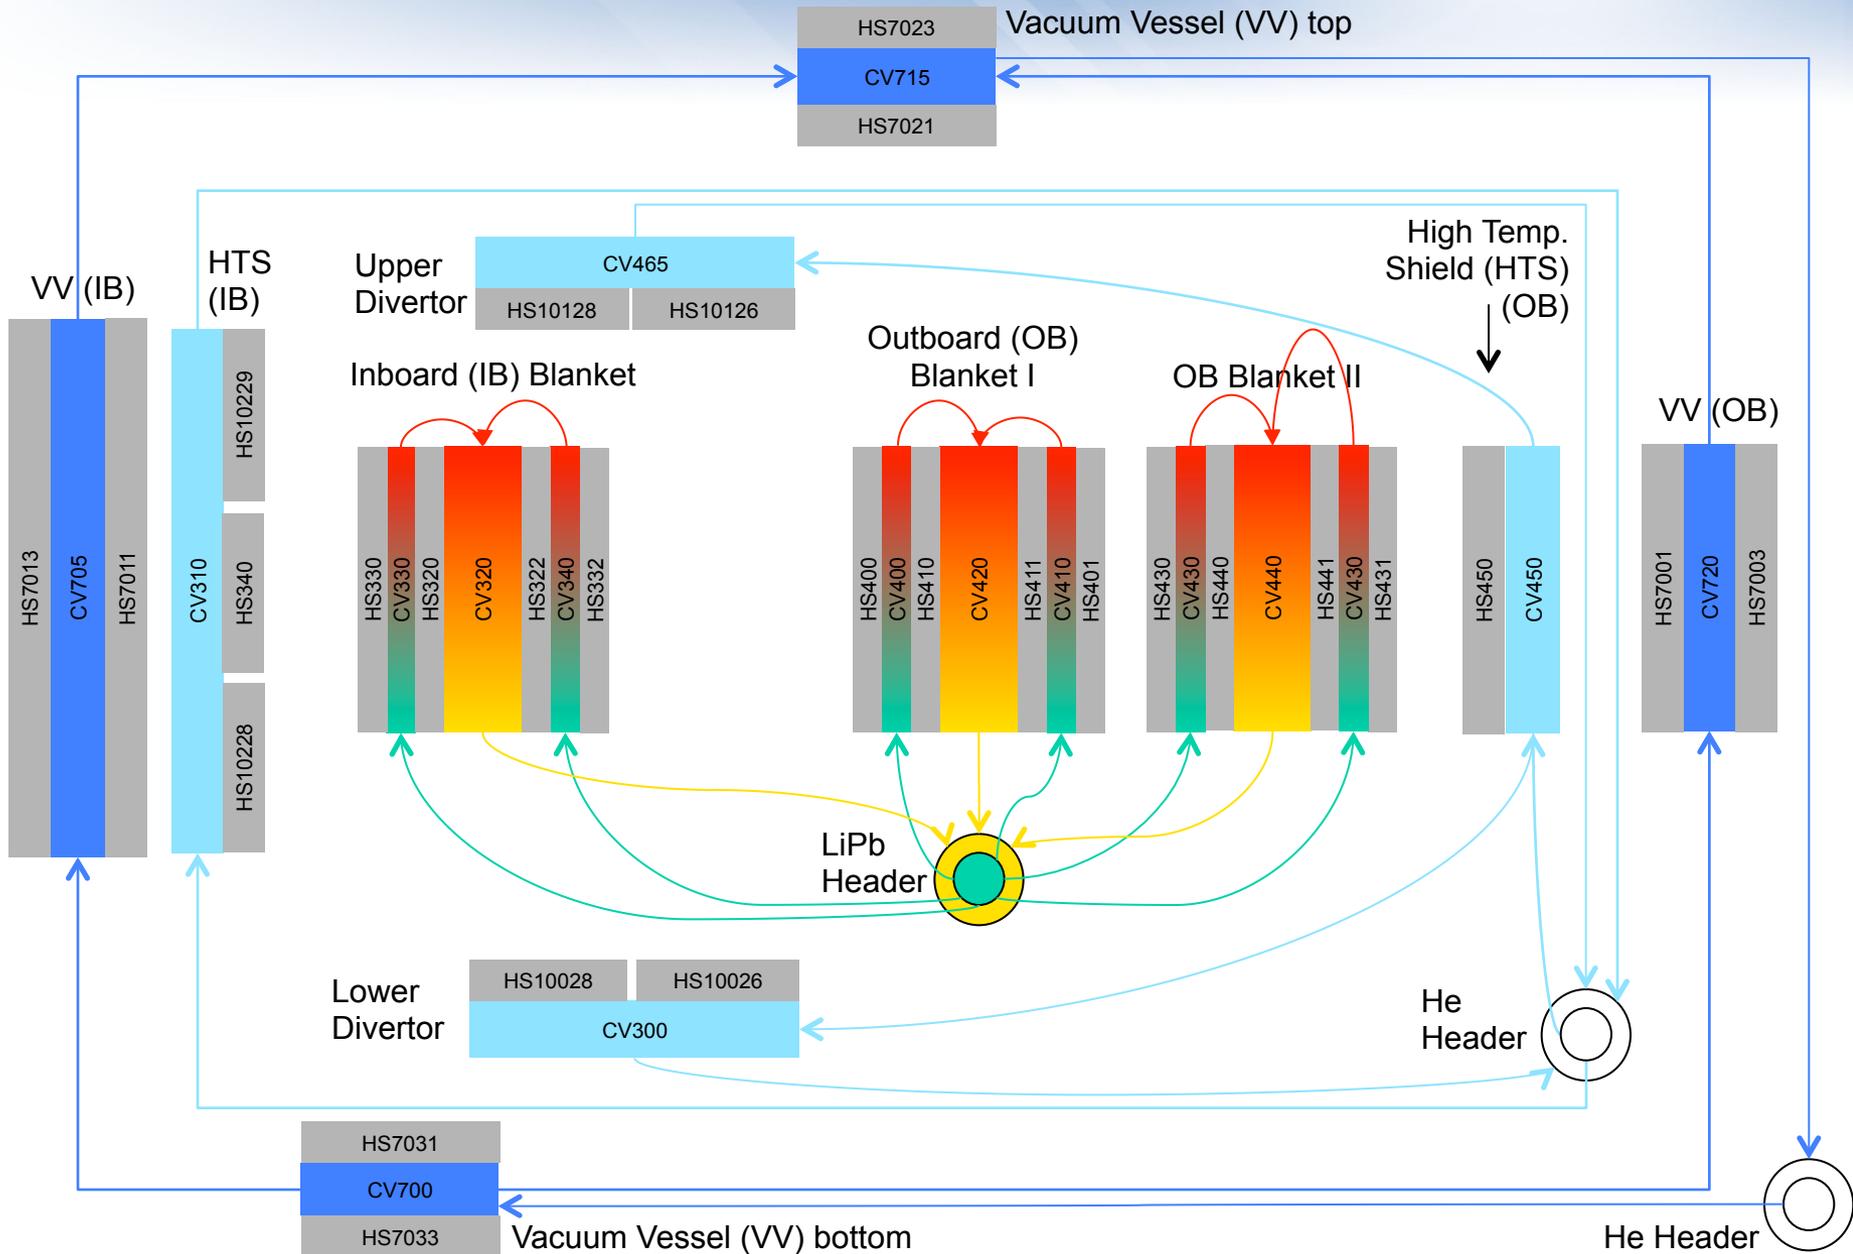
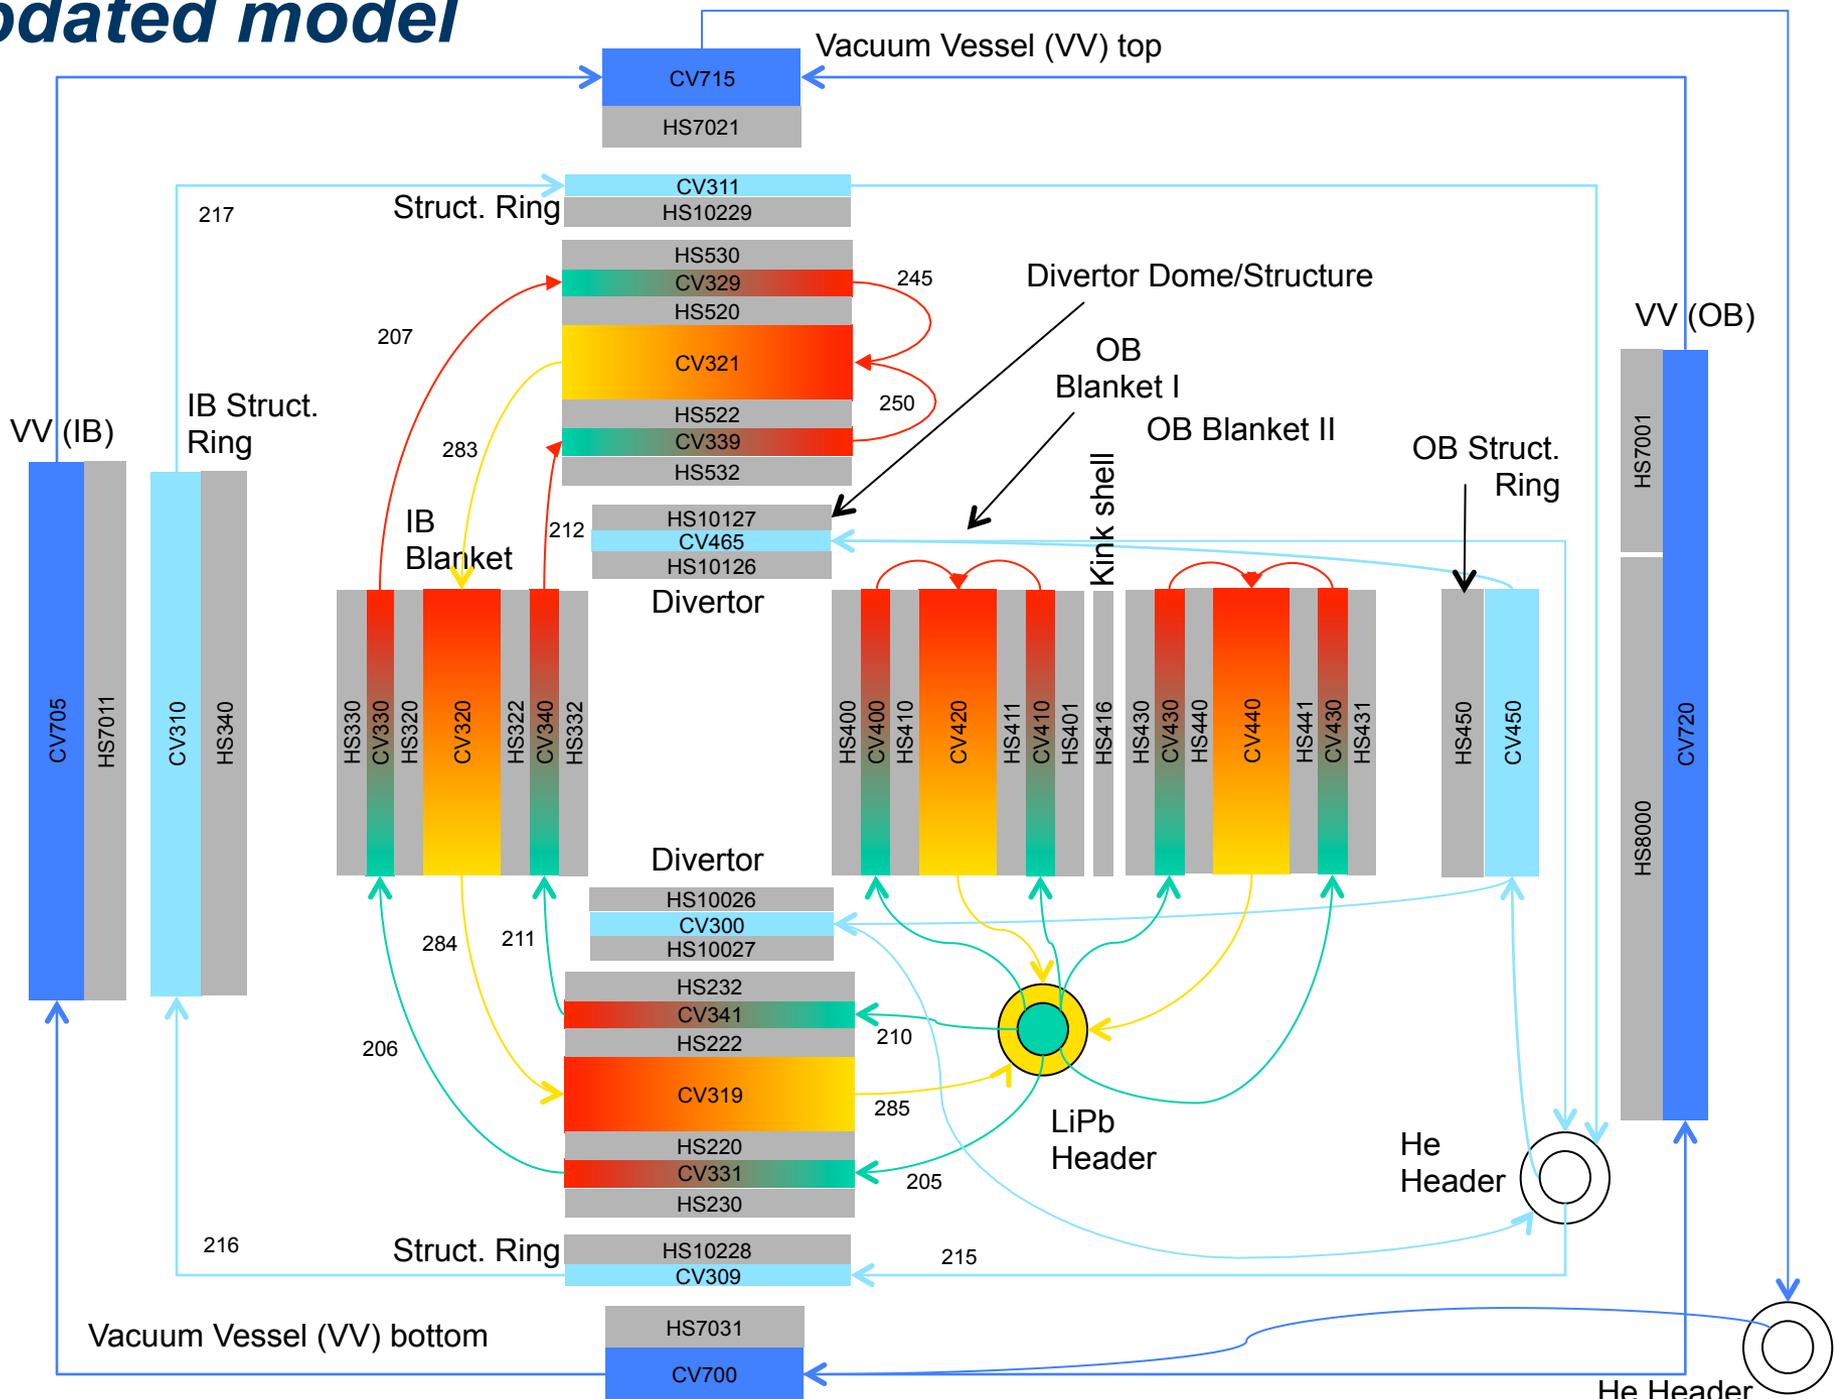
Updated model

- A substantial revision of the base MELCOR model has been undertaken since February to address ACT-1 design changes
 - Final radial build updated
 - Shield plugs added
 - Upper and lower blanket structures and volumes added
 - Kink shell added
 - Divertor dome/steel structure added
 - Modification of decay heats (from Laila) completed
 - Revision of all nuclear heats (Laila's Sept. presentation)
 - He cooling system resized
- Nuclear and decay heats are resulting in higher than desired temperatures

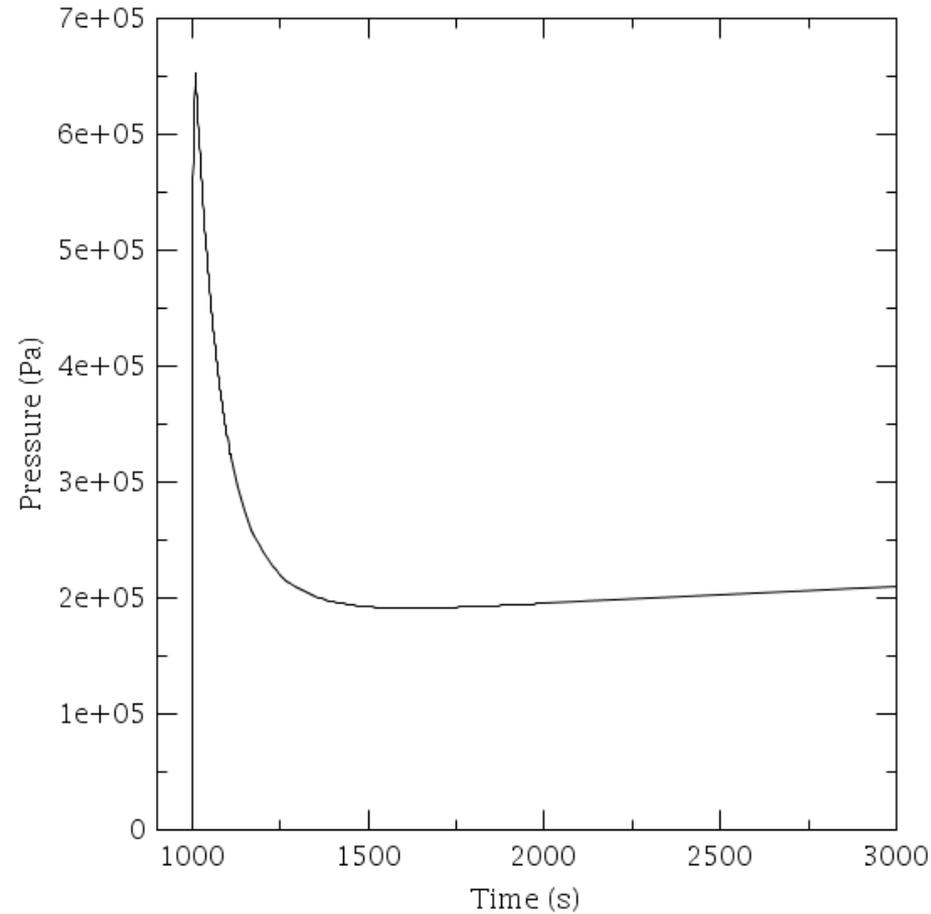
- Previous model

- A Helium (Divertor/steel ring loop) ex-vessel LOCA has been modeled
 - Double guillotine break in outlet pipe
- Primary concern: overpressure in cryostat leading to release of radioactive material
- ARIES-CS guidance: 3×10^5 Pa is pressure limit for the cryostat
- Pressure was too high ($\sim 6.5 \times 10^5$ Pa) based on previous model
 - Ex-vessel coolant volumes resized such that there is a ratio of 2:1 ex-vessel:in-vessel He

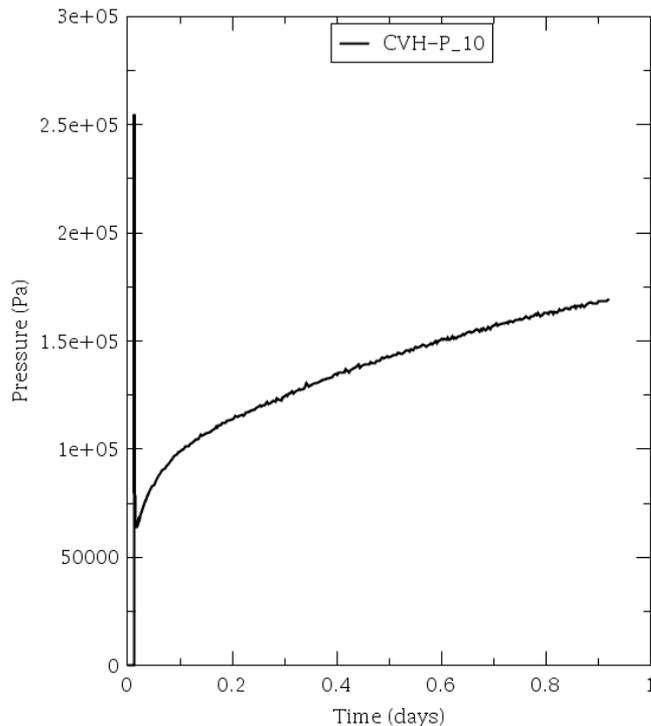
- At longer times, the cryostat pressure builds and heat is transferred through the walls to the environment

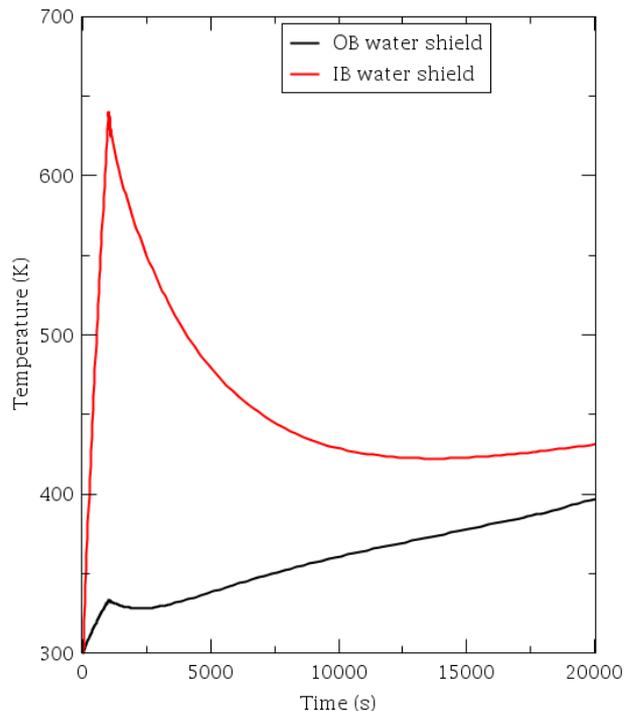
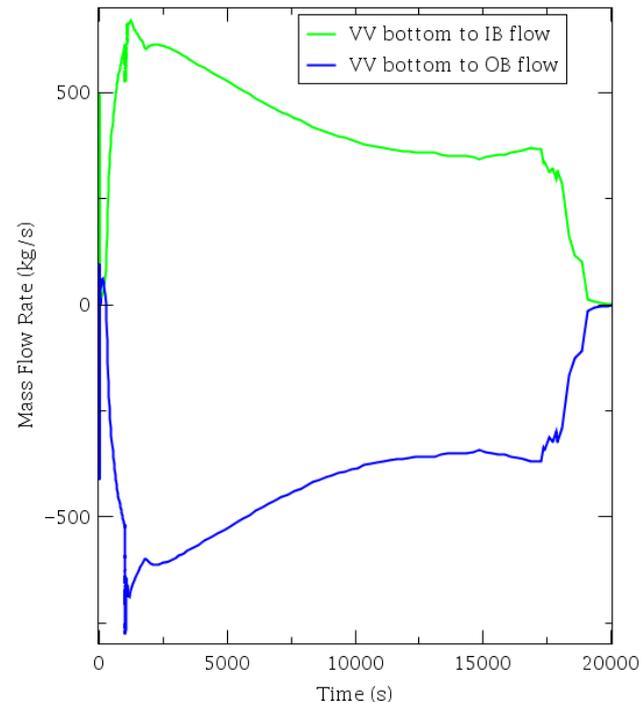
LOFA+LOCA analysis

- LOFA plus water LOCA case is running (a MELCOR bug has been identified by this case and is being resolved)
- Preliminary results show some interesting natural circulation phenomena
